SERVICE BULLETIN

Bulletin No. 623A

SUBJECT: Inspection of impulse coupling cam assemblies.

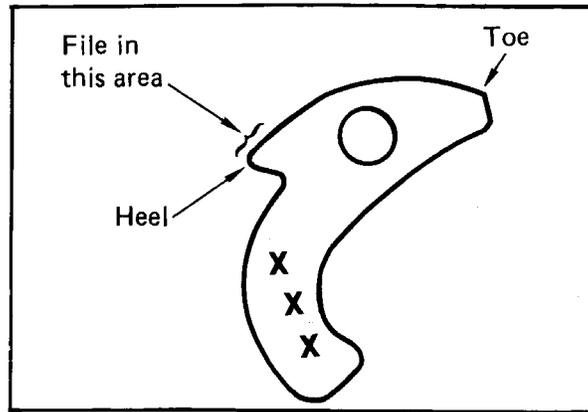
Figure 1

Some improperly heat treated (soft) flyweights have been reported on impulse couplings currently in service. If this condition exists and is not detected, impulse coupling failure could occur. The flyweights must be inspected in accordance with

1. Following published procedures remove the magneto from the engine.
2. Place the magneto in a suitable work stand with the impulse coupling facing up.
3. Use finger pressure to push inward on the toe (see figure 1) of each flyweight so that the flyweight heel protrudes outward.
4. Using a fine #1, double cut, 1/2 inch wide file, at least 3/32 inch thick, pass the file across the heel of the flyweight attempting to remove material. (See figure 1). If the flyweight has been properly heat treated the file will "glide" smoothly over the heel of the flyweight, removing no material. If the flyweight is not properly heat treated (soft), the file will not "glide" easily across the surface of the flyweight heel, and material will be removed.

XXX indicates heat treated flyweight by lot number

12. A new method of marking is being implemented to permanently identify heat treated cam assembly flyweights. See figure "1" for location. Pending consumption of current inventory, there will be a mixture of assemblies identified by the following methods.

1. Original method ----- Yellow paint (Dykem or Lacquer) on the heel of each flyweight.
2. New method ----- Stamped numbers as indicated in figure "1" on each flyweight.

5. If an improperly heat treated (soft) flyweight is found, immediately remove and replace the cam assembly and/or the impulse coupling assembly following procedures in the magneto overhaul instructions, and paying strict attention to notes and cautions.
